SmartTouch 720/725

OPERATORS: SLIDEDRIVER II - SD15, SD40, SD50F, SD80V, SD200V

DATE: 07/2024

SUBJECT: Sunlight & Heat Exposure Issues

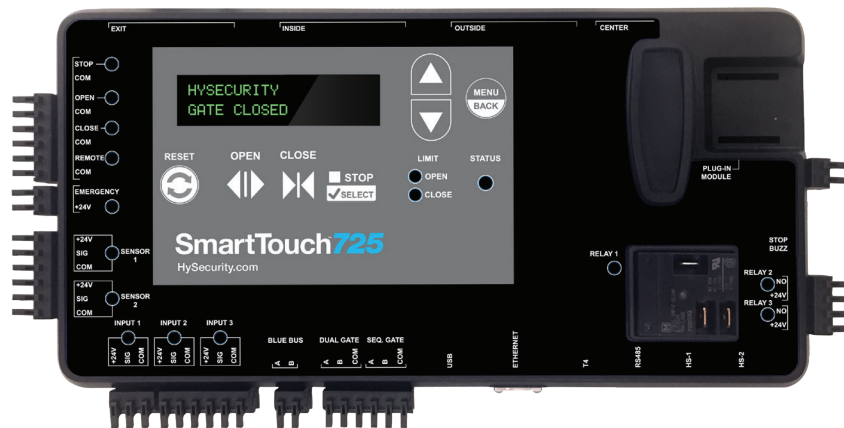
SUBJECT DESCRIPTION: Some HySecurity customers are experiencing deformation of the Smart-Touch 725 controller plastics. This occurs under direct sunlight, generally around mid day and in high heat areas. The controller will visibly deform, rendering the buttons unusable. The operator remains functional and can still be accessed through the iOS or Android apps.

To prevent issues, avoid leaving the electrical enclosure exposed to long durations of direct sunlight. This can be achieved by placing the metal cover back onto the slidedriver chassis. You may also use other means of covering the electrical enclosure as long as there is no functional interference of the wheels or the electric motor.

Replace the SmartTouch 720 (MX5552) or SmartTouch 725 (MX5626) board.
