Technical Bulletin

SmartTouch 720/725

OPERATORS: SLIDEDRIVER II - SD15, SD40, SD50F, SD80V, SD200V

SUBJECT: Sunlight & Heat Exposure Issues

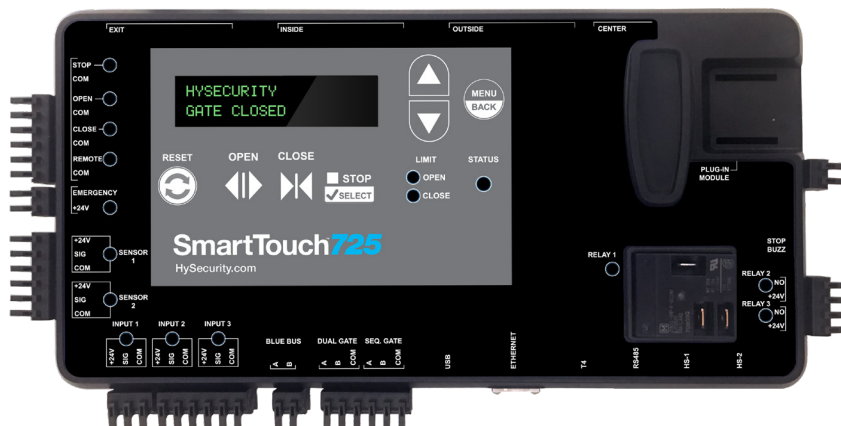
SUBJECT DESCRIPTION: Some HySecurity customers are experiencing deformation of the Smart-Touch 725 controller plastics. This occurs under direct sunlight, generally around mid day and in high heat areas. The controller will visibly deform, rendering the buttons unusable. The operator remains functional and can still be accessed through the iOS or Android apps.

To prevent issues, avoid leaving the electrical enclosure exposed to long durations of direct sunlight. This can be achieved by placing the metal cover back onto the slidedriver chassis. You may also use other means of covering the electrical enclosure as long as there is no functional interference of the wheels or the electric motor.

Replace the SmartTouch 720 (MX5552) or SmartTouch 725 (MX5626) board.
