Titan Actuator Wiring

PRODUCT: Titan 912 and 912L actuators

DATE: 05/27/2021

SUBJECT: Titan actuator wiring.

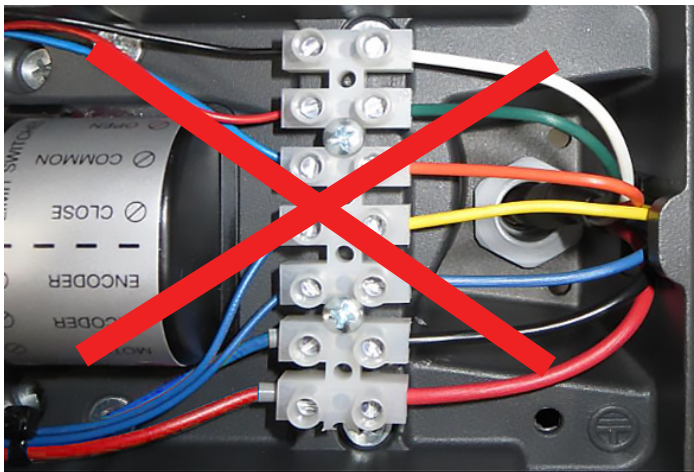
We have discovered that some TITAN actuators manufactured in 2021, and shipped from our facility after May 10, 2021, have the motor and/or limit wires reversed. This causes the motor to operate in the wrong direction with regards to the limits and instruction manuals.

Fig-1: INCORRECT WIRING!

Correct the wiring on the terminal block that can be found near the limit adjust wheels. See Fig-1 and Fig-2 for examples of incorrect and correct wiring. Or you may return the actuator to Nice | HySecurity for a replacement.

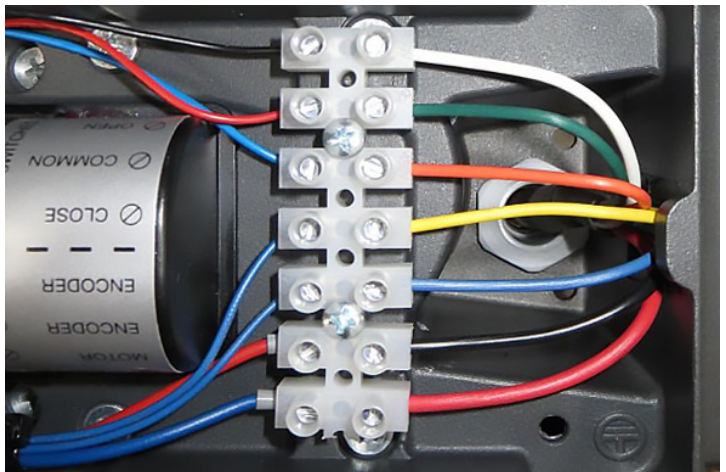
Fig-2: CORRECT WIRING
