Mercury 310 Early Production Issues

OPERATORS: Mercury 310 Controller

DATE: 08/27/2021

SUBJECT: Possible pre-production firmware and sensor registration error

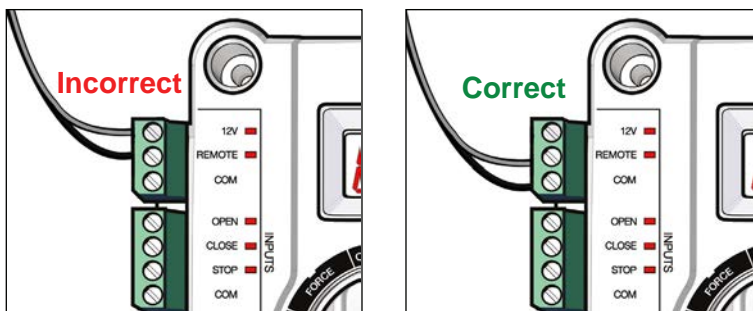
- **Some CBOX 310 units were built with the wiring in the wrong terminals. This will not damage anything but does make the open button non-functional. To correct this, install the button wires between the REMOTE and COM terminals (see images below):**
