Technical Bulletin

Mercury 310 Tactile Buttons Sticking

APPLIES TO: Mercury 310 Control Boards

SUBJECT: Mercury 310 buttons sticking when depressed.

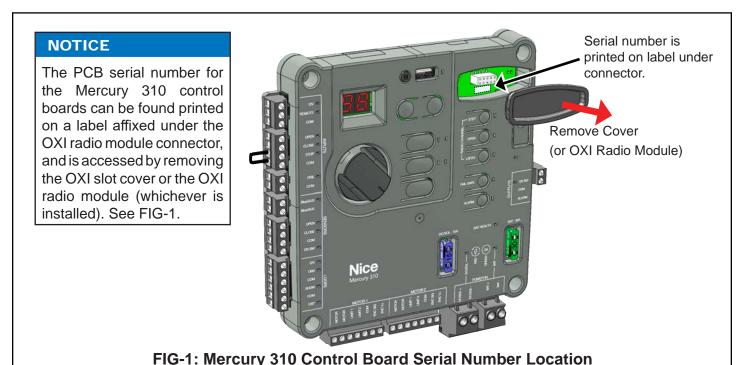
Additionally, if the Control Board serial number falls within the affected range, you may return the control board for a pro-active replacement. Unfortunately, due to global supply constraints, replacement times may be extended. Standard shipping rates will apply. See FIG-1 and note below to access the PCB serial number.

Although the button could be corrected by opening the plastics, it is likely to occur again in the future. We recommend returning the product under warranty.
